Manhole Inspection Summary

Manhole # S41C__022MH

Location Address: **1403 e fayette st**

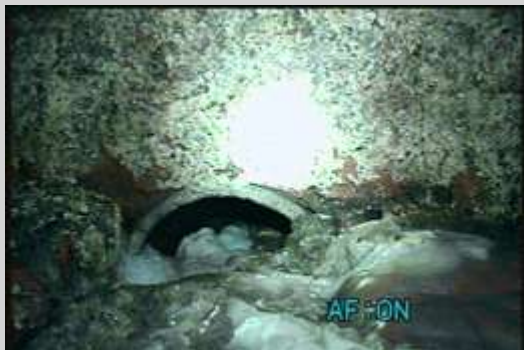
12 O'Clock Outflow

8 in. Circular Gravity Sewer
Pipe Out @ 12 O'Clock

Pipe Material: **Clay** ☐ Pipe Lined

Infiltration: **None** Pipe Seal Cond: **Unknown**
